Queensmere Shopping Centre, Slough – refurbishment of a 1970s shopping centre

ENERGY EFFICIENCY

**BEST PRACTICE
PROGRAMME**

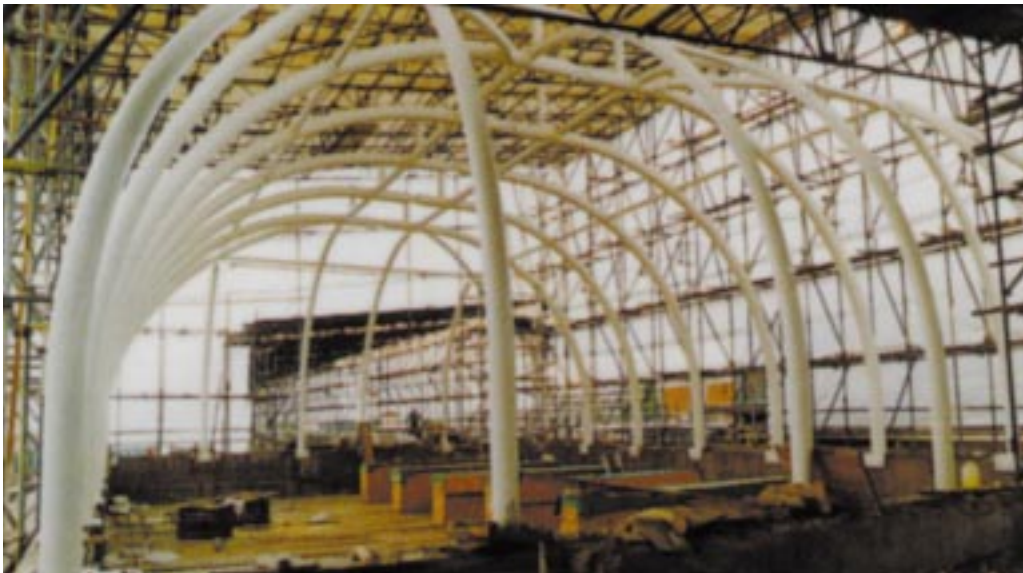
Figure 1 Construction of new domed roof during refurbishment

- The roof lights were replaced with a central dome of glass and steel.
- New pendant lighting was installed.
- The floor was levelled.

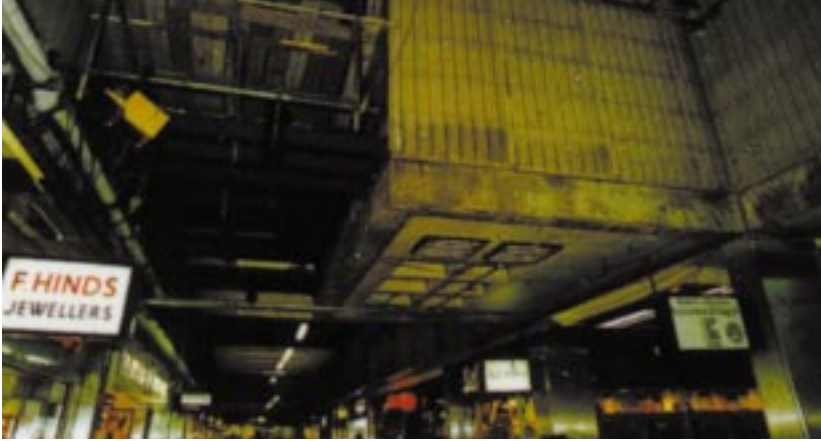
Figure 2 Approach to Allders Square in May 1997

By the 1990s Queensmere Shopping Centre was in need of refurbishment. It looked very dated and did not provide the type of accommodation or quality of environment required by today's retailers. It was also expensive to operate. The Centre had full heating and air-conditioning in the malls and the lighting was not energy efficient.

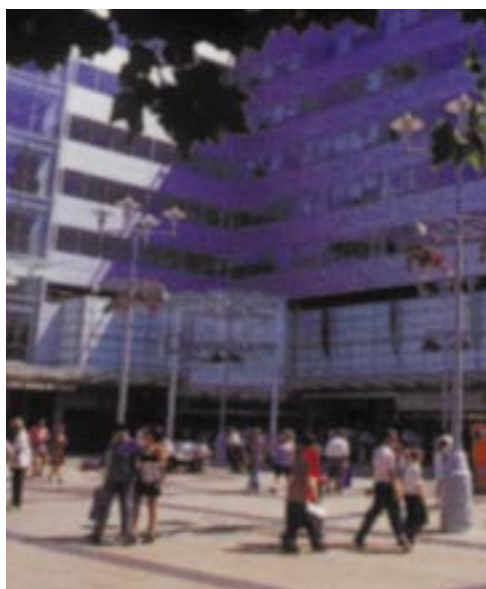
Figure 3 Refurbished Town Square and public sculpture

- Concrete panels were overlaid with opaque glass.
- A glazed canopy was created around three sides of the Square, and the Centre entrance was emphasised with a large canopy featuring the new Queensmere logo.
- The undercroft areas were converted to retail and café units.
- New paving contrasting with the High Street paving was laid to give the sense of a distinct space.
- New outside light fittings and floodlighting were installed.
- A public sculpture made by the local community – a stainless steel tree with birds – was commissioned and installed in Town Square.

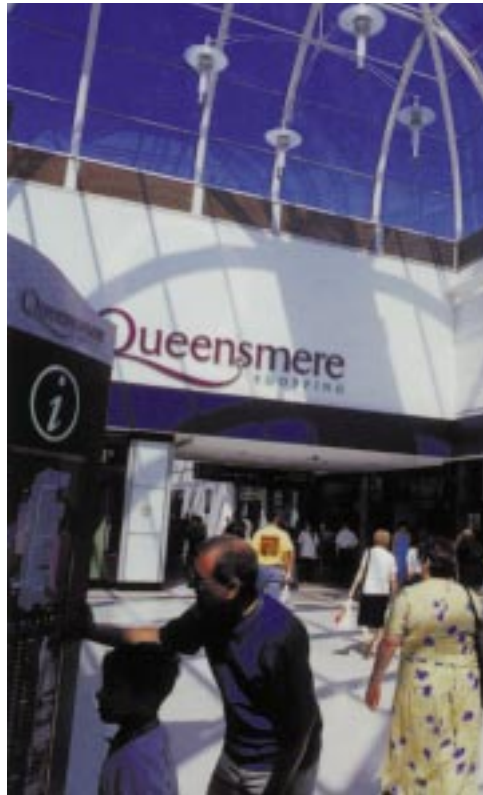
Figure 4 Allders Square showing new domed roof and pendant lighting

The natural ventilation system utilises the stack effect which is facilitated by the new arching roof structure. Roof lights automatically open when the mall reaches 19°C, drawing fresh air through the malls.

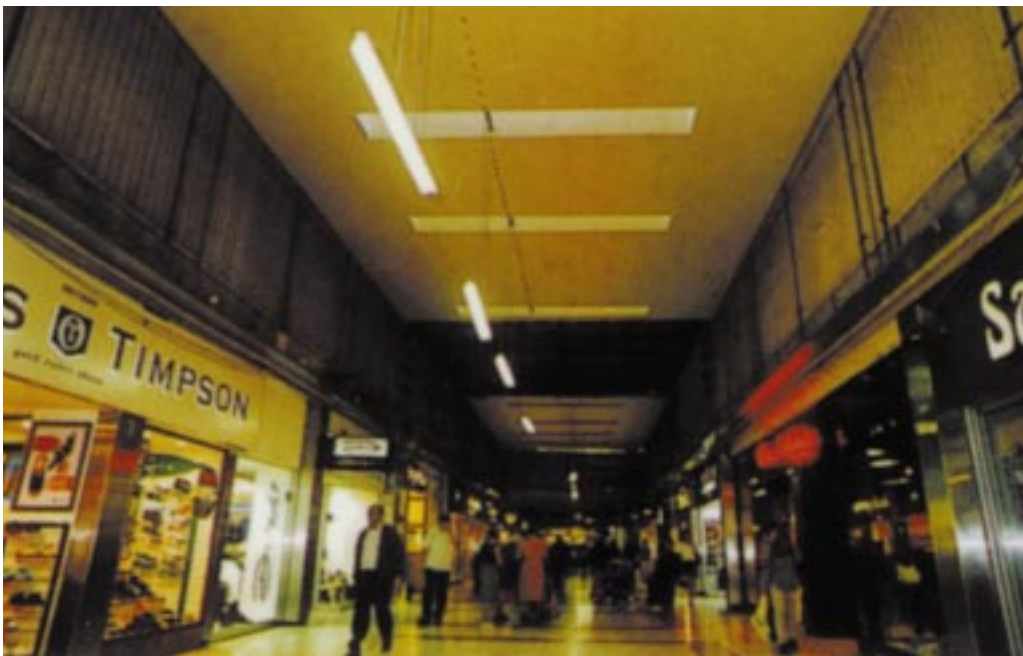
Figure 5 Curzon Mall during refurbishment

New glazed roofs were installed in Curzon Mall and Allders Square. The old lighting system was removed and a new system with feature

pendant lighting and spotlighting was installed. This system gives greatly improved levels of illumination and utilises energy-efficient, compact fluorescent lamps and high-frequency ballasts.

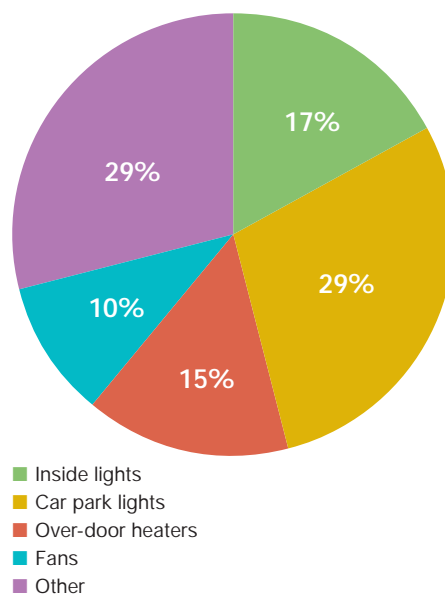
Figure 6 shows the estimated split of energy consumption in the Centre. (The 'other' category includes domestic hot water, small power, automatic doors and security equipment.)

Figure 6 Breakdown of energy use

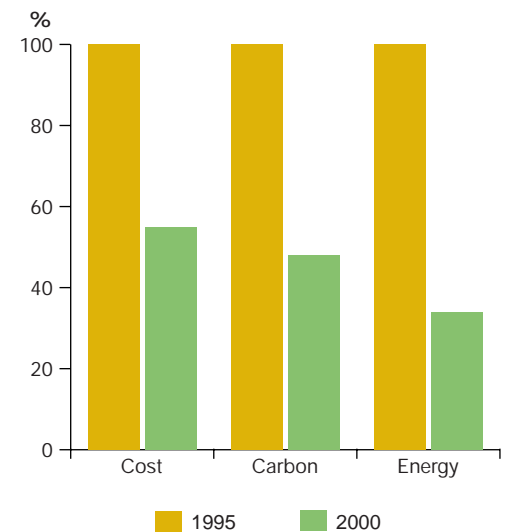
Figure 7 shows energy consumption before and after the refurbishment. It does not include savings on maintenance.

Figure 7 Effect of refurbishment on energy consumption

- Yearly energy costs have been cut from £98 017 to £53 326, saving £44 691. This is a saving of 46%.
- The amount of energy used has been reduced by 65% – 2 380 844 kWh a year.
- Carbon emissions have been reduced by 53% with a reduction of 186 tonnes of carbon a year.
- Maintenance costs have also been reduced because there is no longer a need to maintain boiler and chiller plant. Maintenance staff have been reduced from five to two – a saving of £53 000 a year.

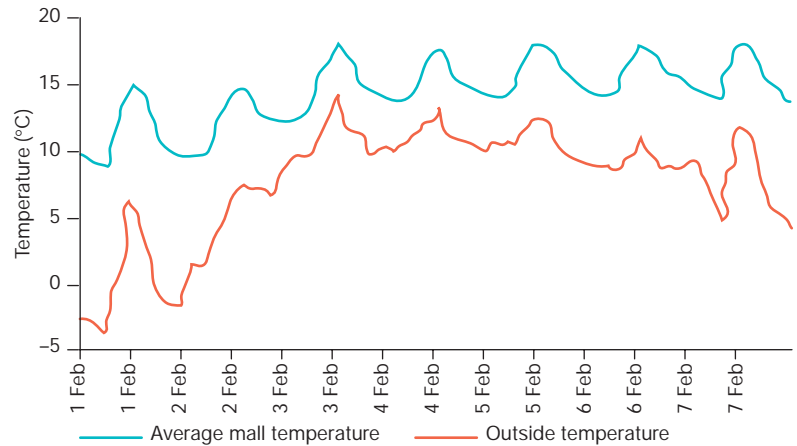
The temperatures in the Centre during the winter period were an average of 7.6°C warmer than the outside temperatures. The average temperature inside the Centre was 14.3°C.

Figure 8 shows the average mall temperature compared to the outside temperature during the first week in February.

Figure 8 Winter temperature profile

Monitoring showed the temperatures in the malls in winter to fluctuate between 12°C and 17°C. Mall temperatures were on average 7.6°C warmer than outside temperatures. These temperatures should not feel cold for shoppers wearing coats but tenants wearing indoor clothing could find them cold. Tenant dissatisfaction with temperatures could be due to expectations. Traditionally malls have been heated and cooled as was Queensmere prior to refurbishment.

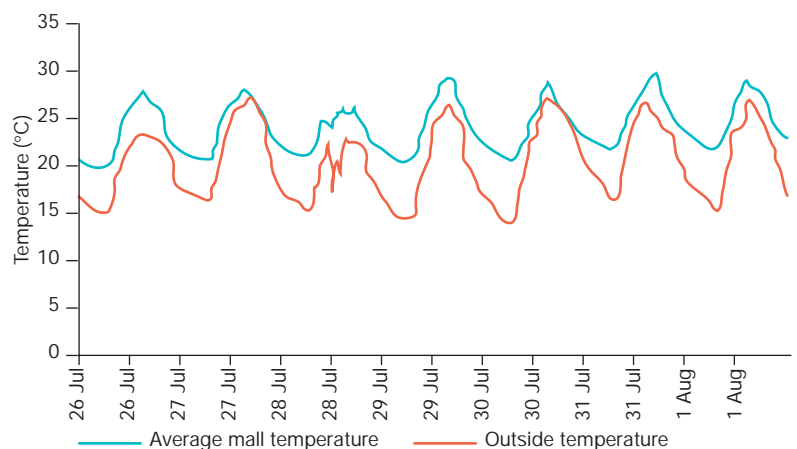
During the summer, temperatures were closer to external temperatures, with it being up to 3°C warmer in the Centre.

Figure 9 shows the temperatures during the last week in July. During opening hours the temperature in the Centre was between 15°C and 25°C for 75% of the time. The temperatures remained within the target band of 13°C to 26°C for nearly 90% of the time.

Figure 9 Summer temperature profile

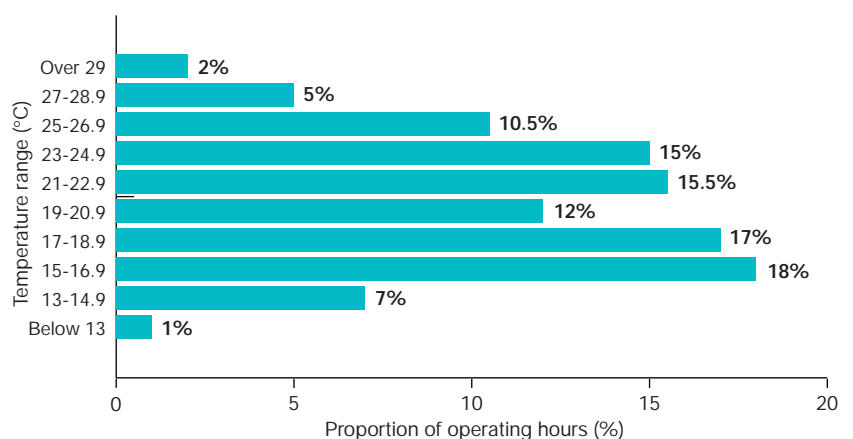
Figure 10 shows the proportion of occupied hours for which the temperature was within certain bands.

Figure 10 Temperature during operating hours

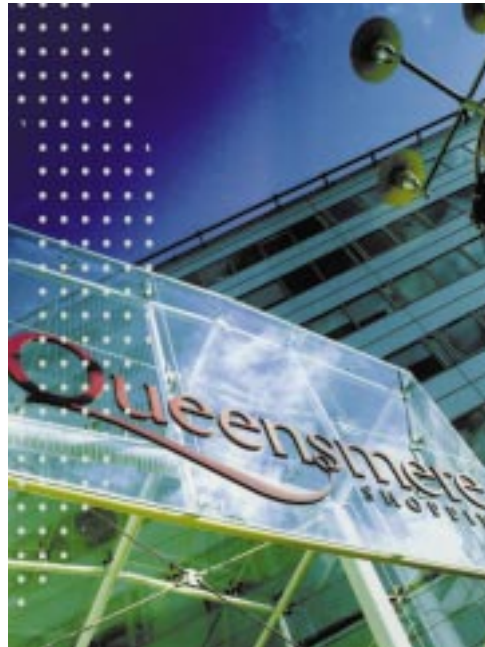
Figure 11 New glazed canopy over main entrance to the Centre
